Land Disposal of San Luis Drain Sediments,  
Panoche Water District, South Dos Palos, California

Joint Project Report by Lawrence Berkeley National Laboratory and  
LFR Levine-Fricke

May 28, 2002

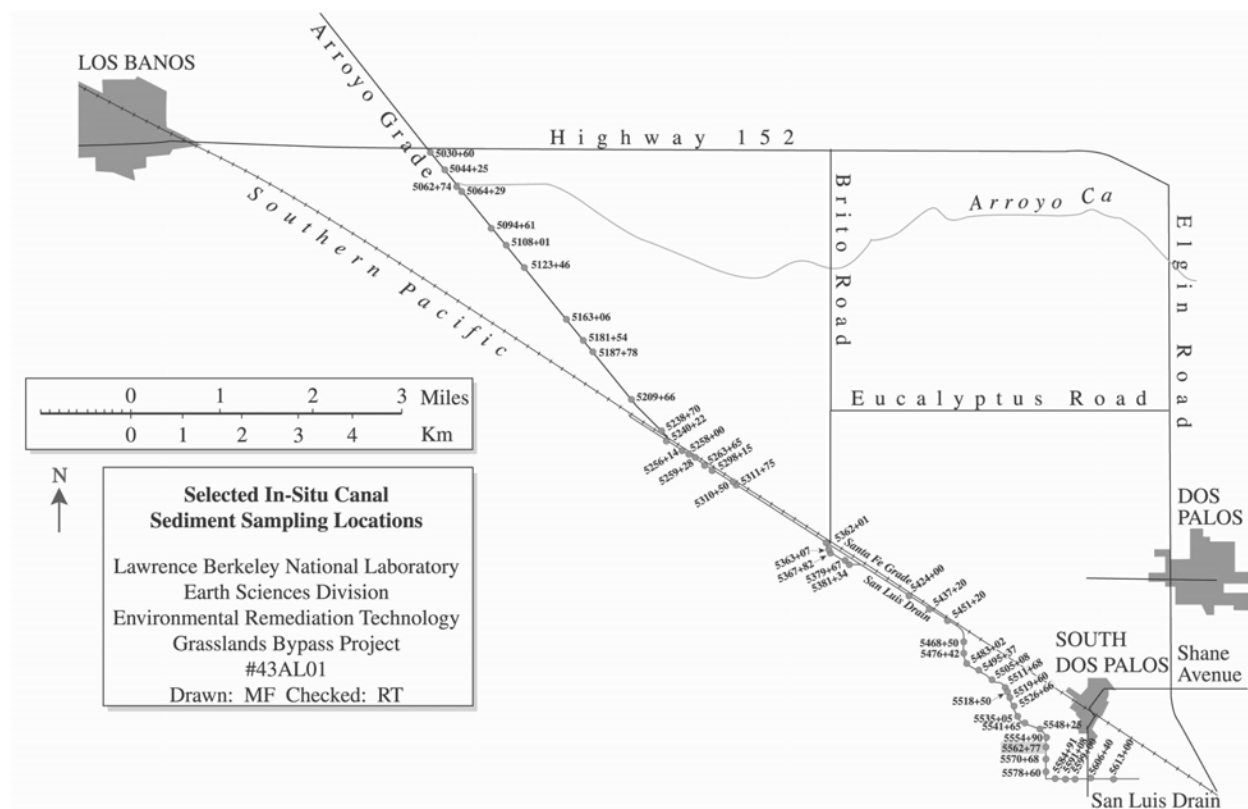
Figure 1: Location of LBNL sediment sampling points along the SLD.

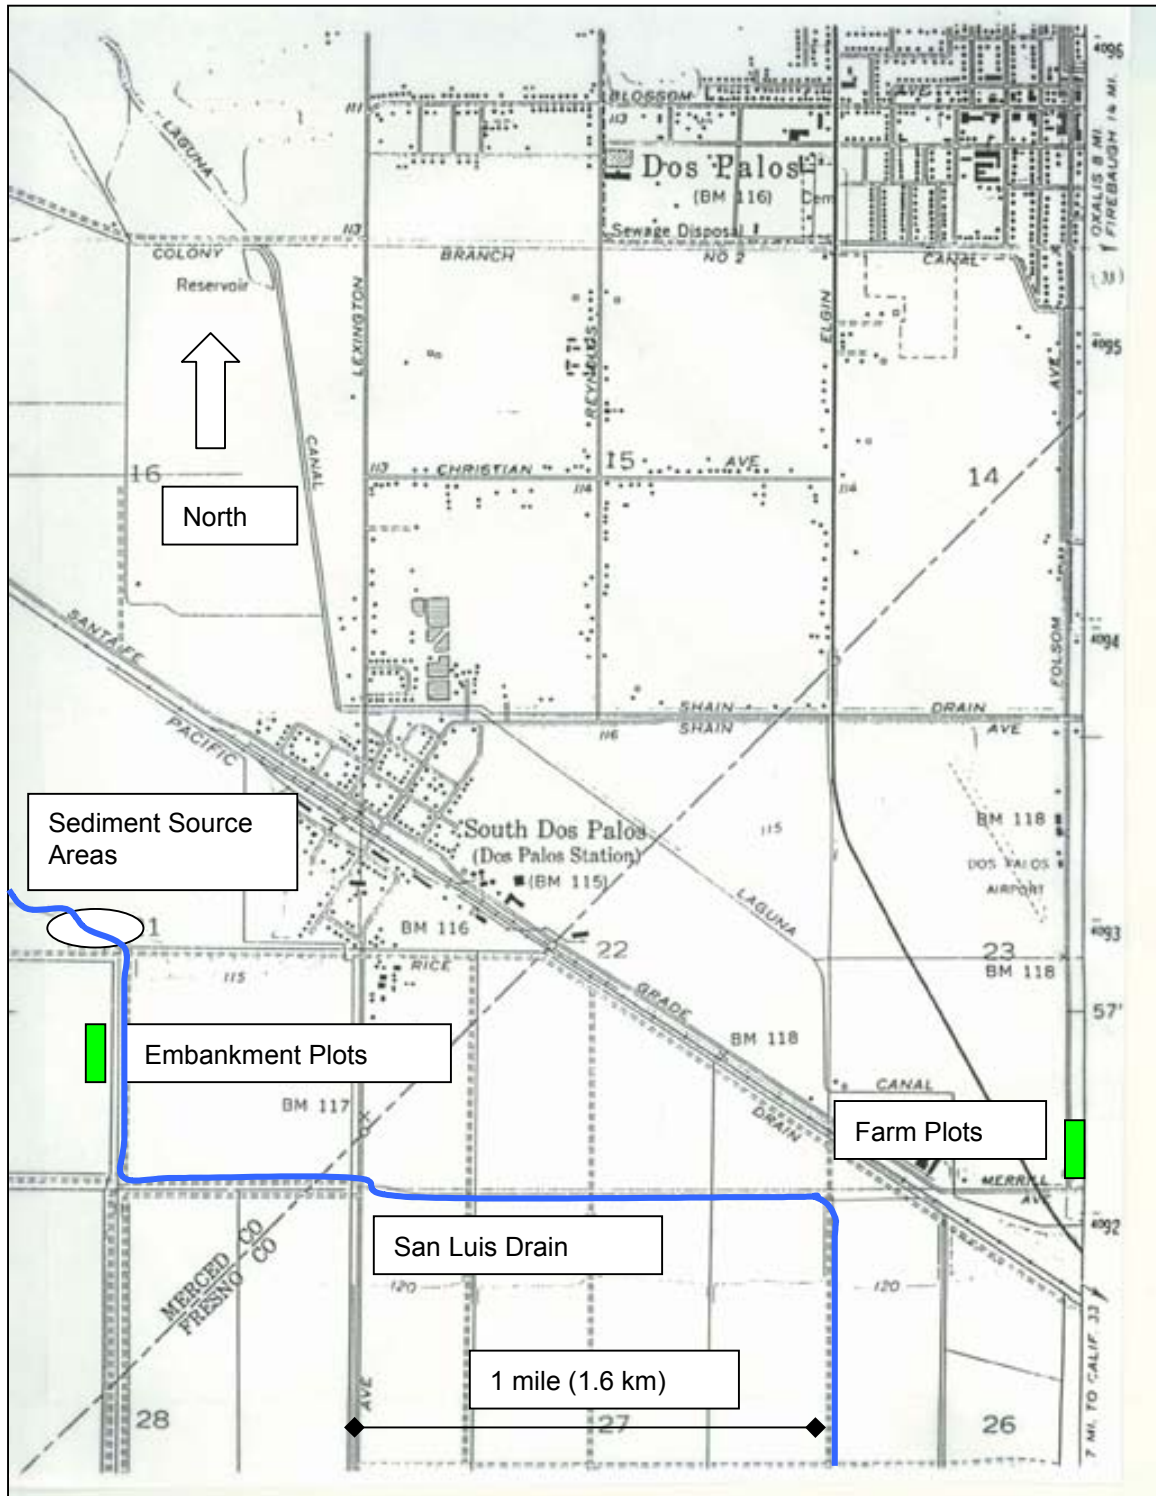
Figure 2: Locations of sediment source areas, embankment plots, and farm plots, relative to the SLD.

Two sites were selected for the pilot-scale application. Both are south of Dos Palos (Figure 2). Sediment from Source Areas 1 through 3 was laid down on the adjacent or nearby embankment, west of the SLD, in embankment plots (EPs) 1, 2, and 3 (EP-1, EP-2, and EP-3), respectively. The embankment was chosen because it is a likely candidate for large-scale sediment disposal, due to its proximity to the source area, easy access, and well-compacted, engineered soils, which limit infiltration. Sediment from Source Areas 4 and 5 was laid down on two farm plots (FPs) within a cultivated field, FP-1 and FP-2. This type of application is another candidate for large-scale disposal. It offers the advantage of a far

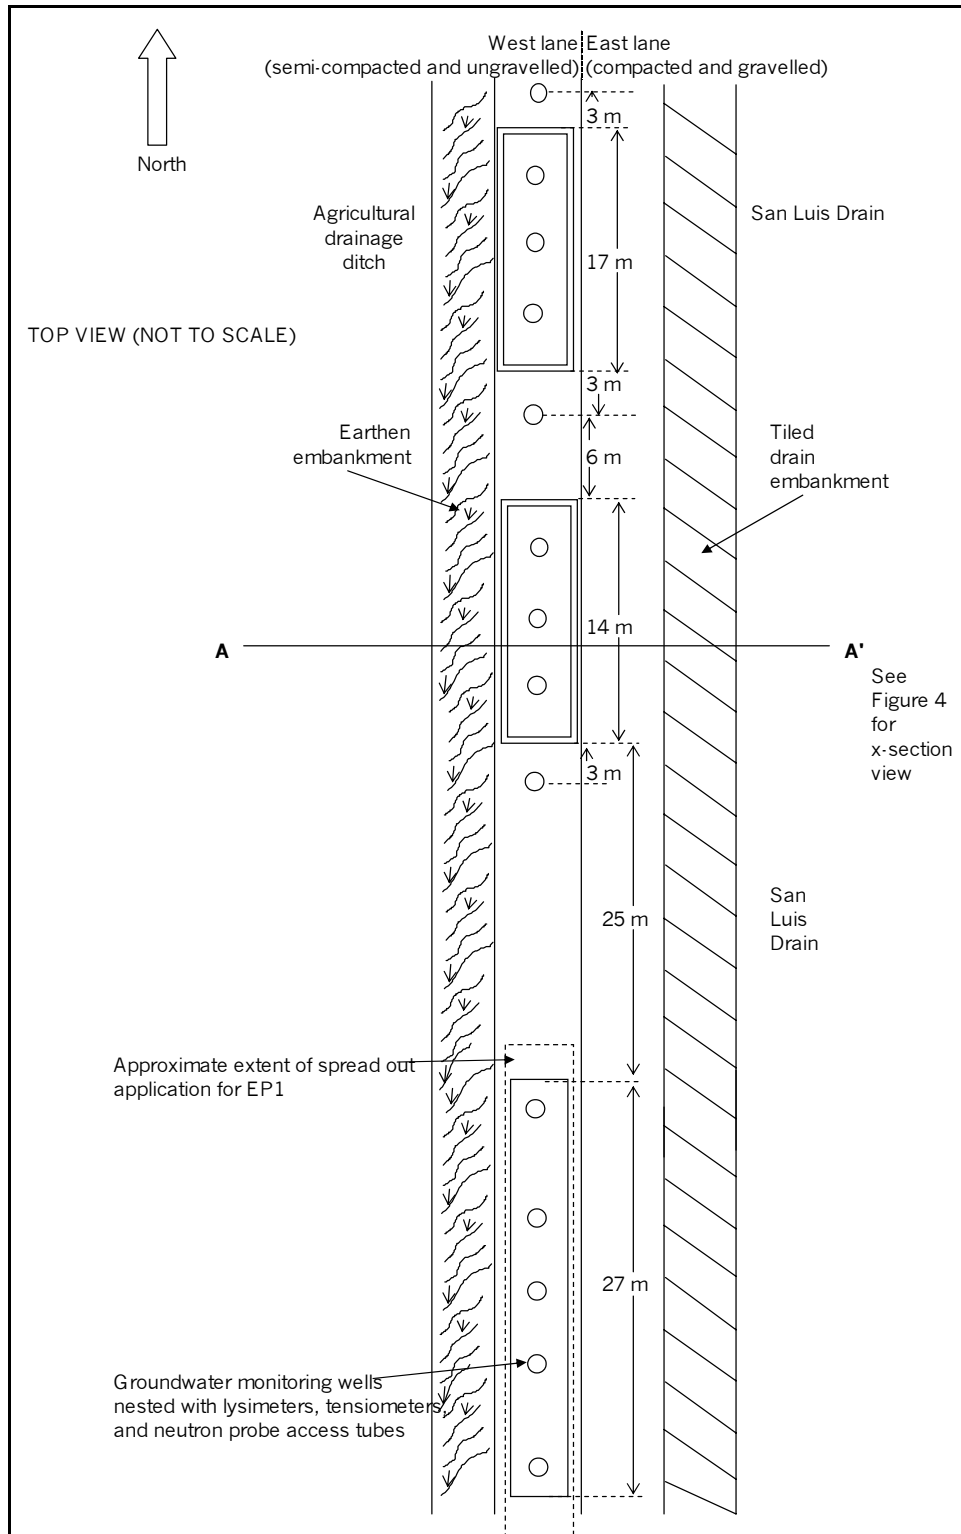
Figure 3: Layout of embankment plots and monitoring equipment.

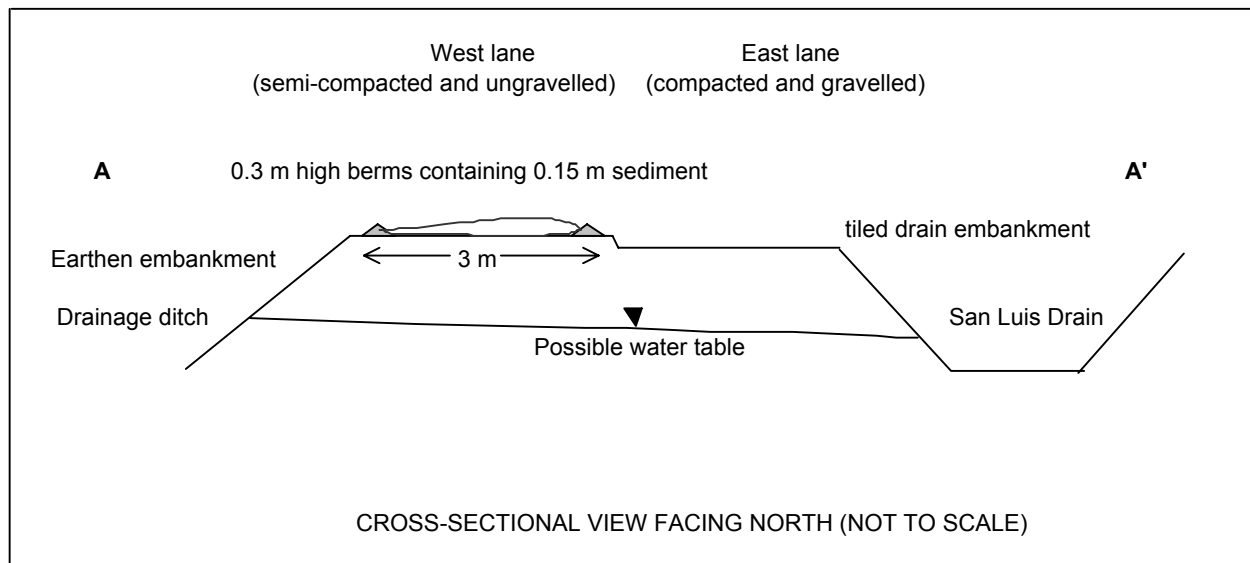
*Figure 4: Cross-sectional view of embankment plots along Section A-A'.*

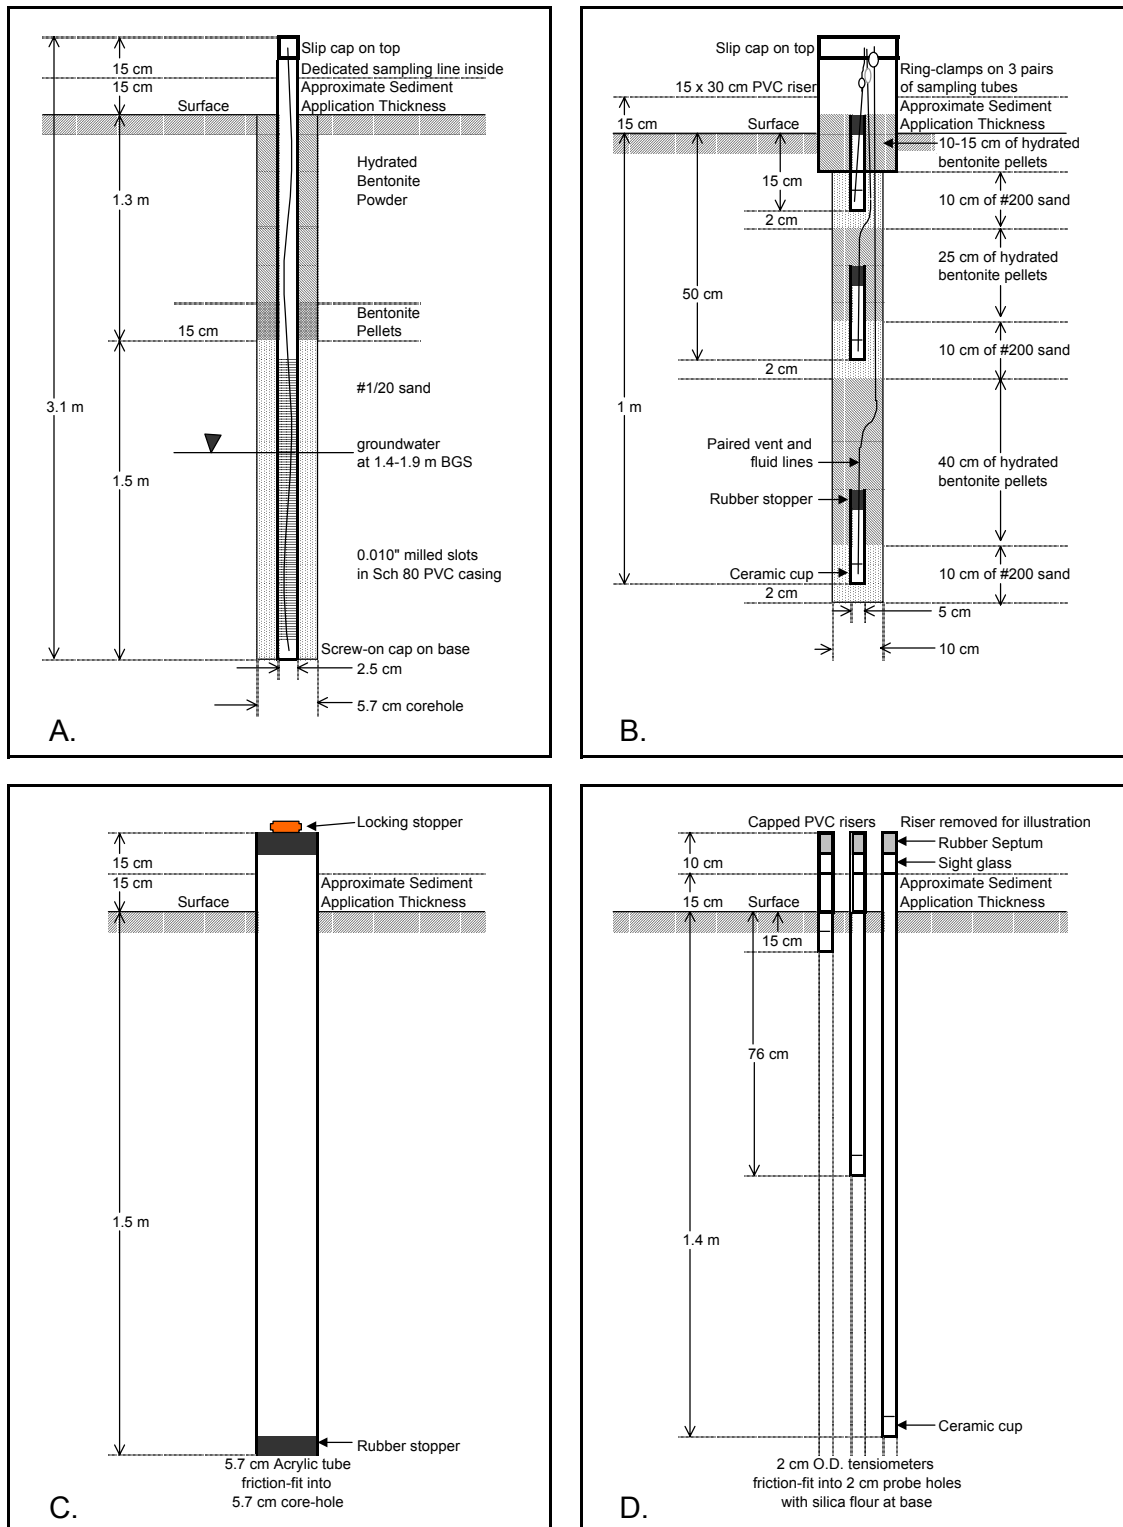
Figure 5: Construction detail of embankment plot instrumentation: a.) groundwater monitoring well; b.) suction lysimeter; c.) neutron probe access hole; and d.) tensiometer cluster.

- Five 5-cm-diameter cores were drilled into each plot.
- For each plot, one core was drilled to 2.4 m in an effort to locate the water table, one core was drilled to 1.5 m (the apparent water table), and three cores were drilled to 1.2 m.
- All cores were retained and sectioned into 15-cm intervals for subsequent processing and analysis.
- Geological conditions were uniform across both plots: dark gray silty clay from 0 to 0.45 m, medium olive brown clay from 0.45 to 1.5 m, and medium brown clay with sand from 1.5 to 2.4 m.
- Temporary lysimeters (4.7-cm diameter) were installed in 2.4-m- and 1.5-m-deep holes, reamed to 6.3 cm. The lysimeters were set with lines for water sampling and air venting to the surface. Silica flour was used to fill the annular space around the ceramic cup and bentonite pellets were used to isolate the ceramic cup stratigraphically. Tie lines were

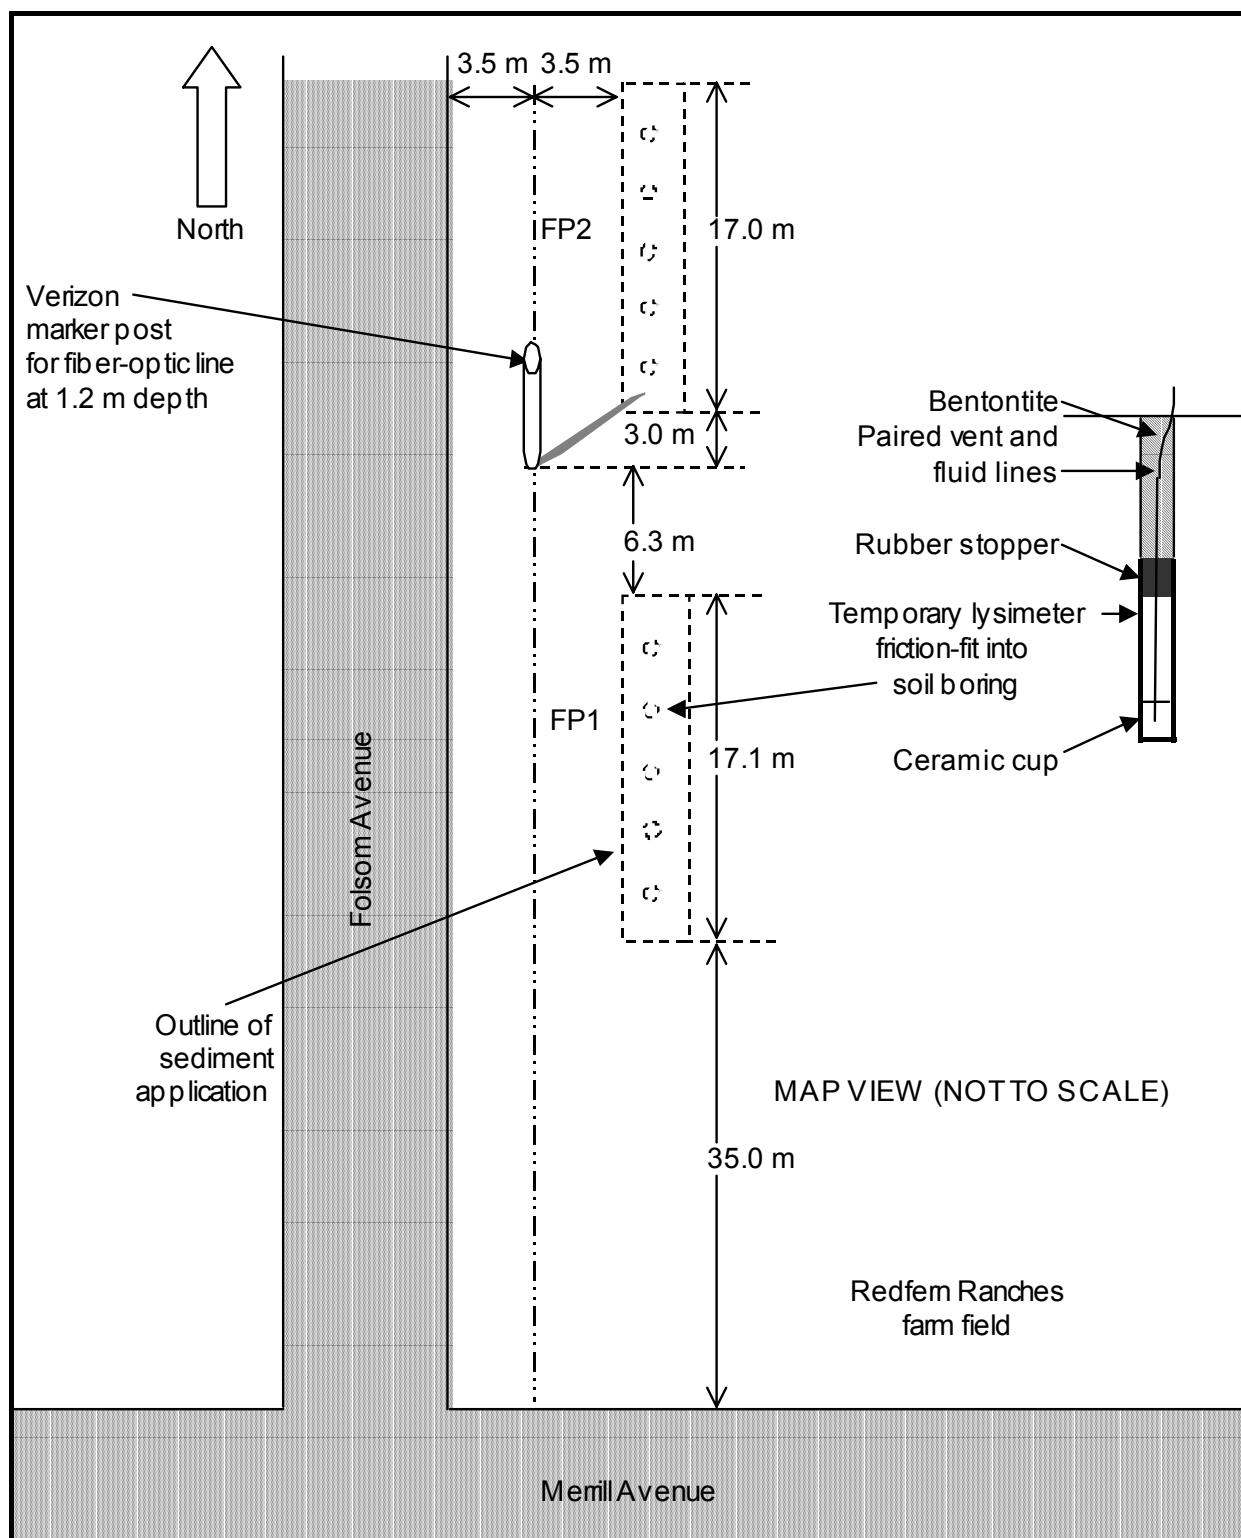
Figure 6: Layout of farm plots, locations of soil borings, and temporary lysimeter design.

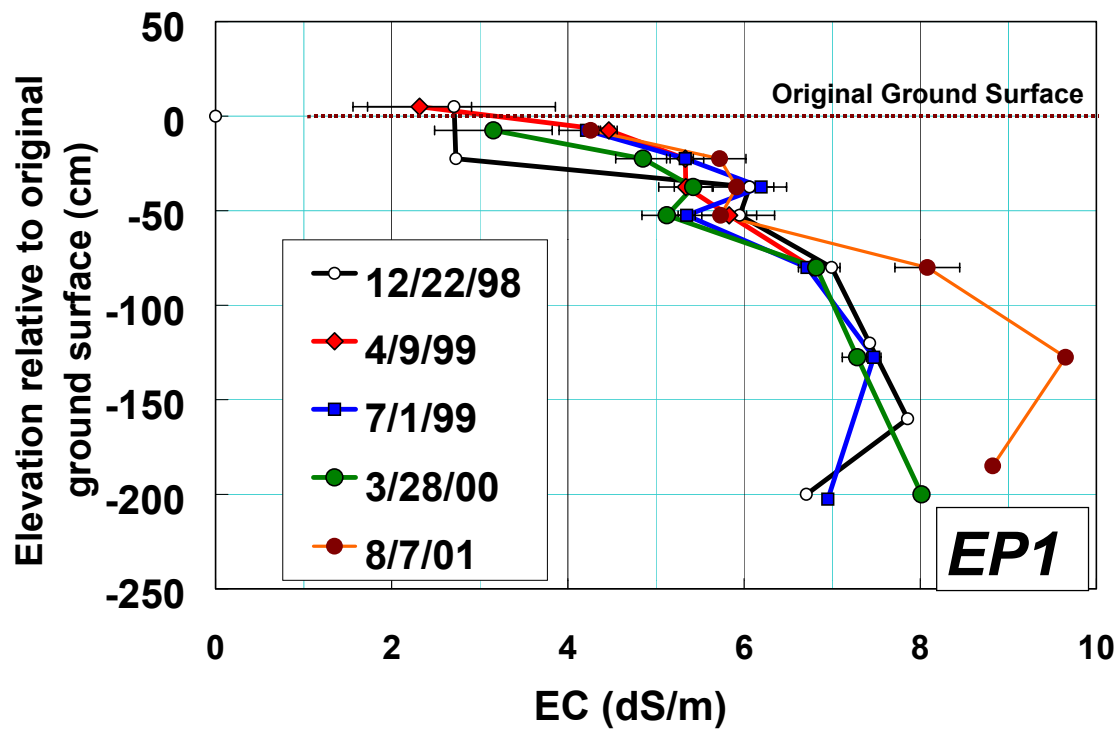
Figure 8: Electrical conductivity in water extracts of soils collected in EP-1. Error bars represent one standard deviation on either side of the mean.

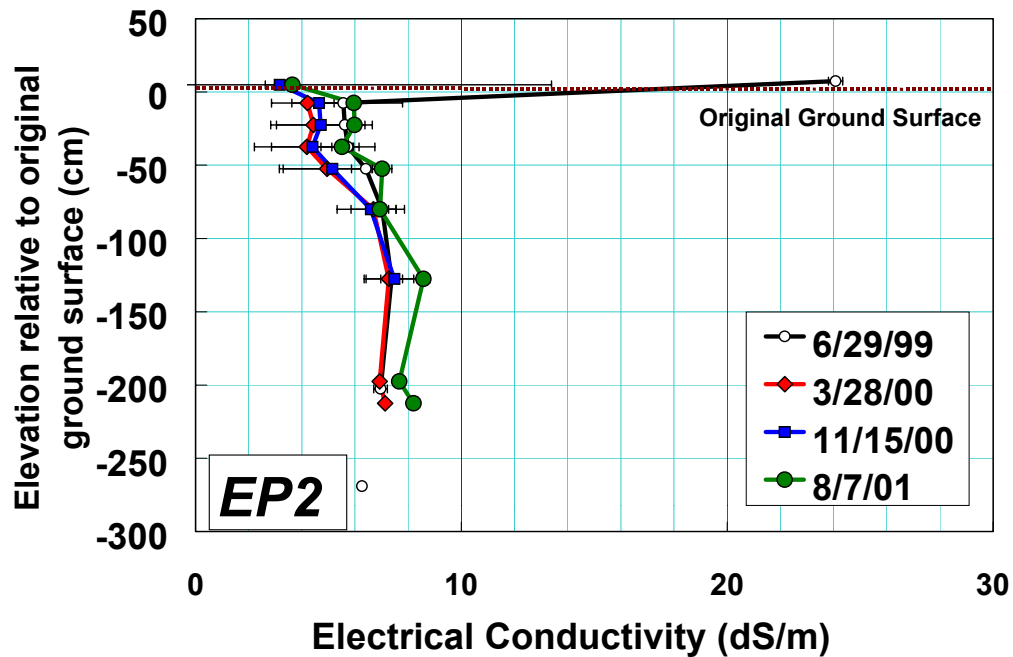
Figure 11: Electrical conductivity in water extracts of soils collected in EP-2. Error bars represent one standard deviation on either side of the mean.

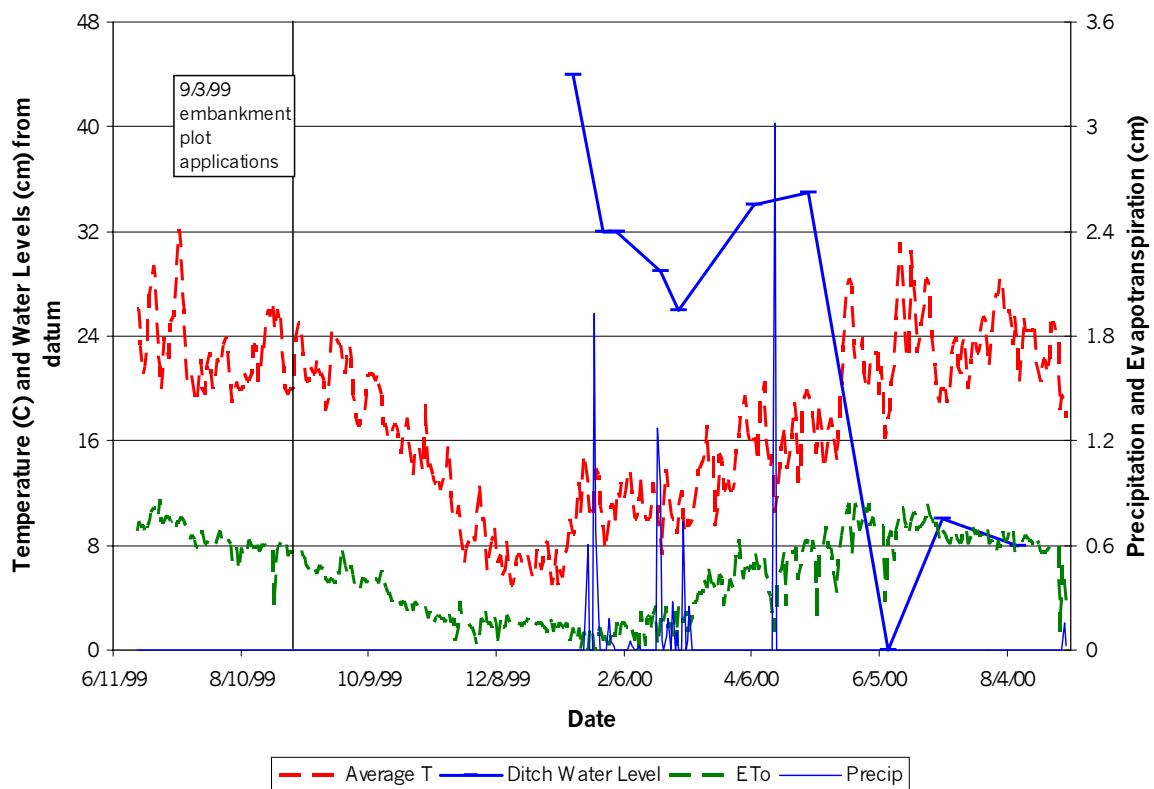
Figure 12: Daily weather records and ditch water levels at the embankment plots.

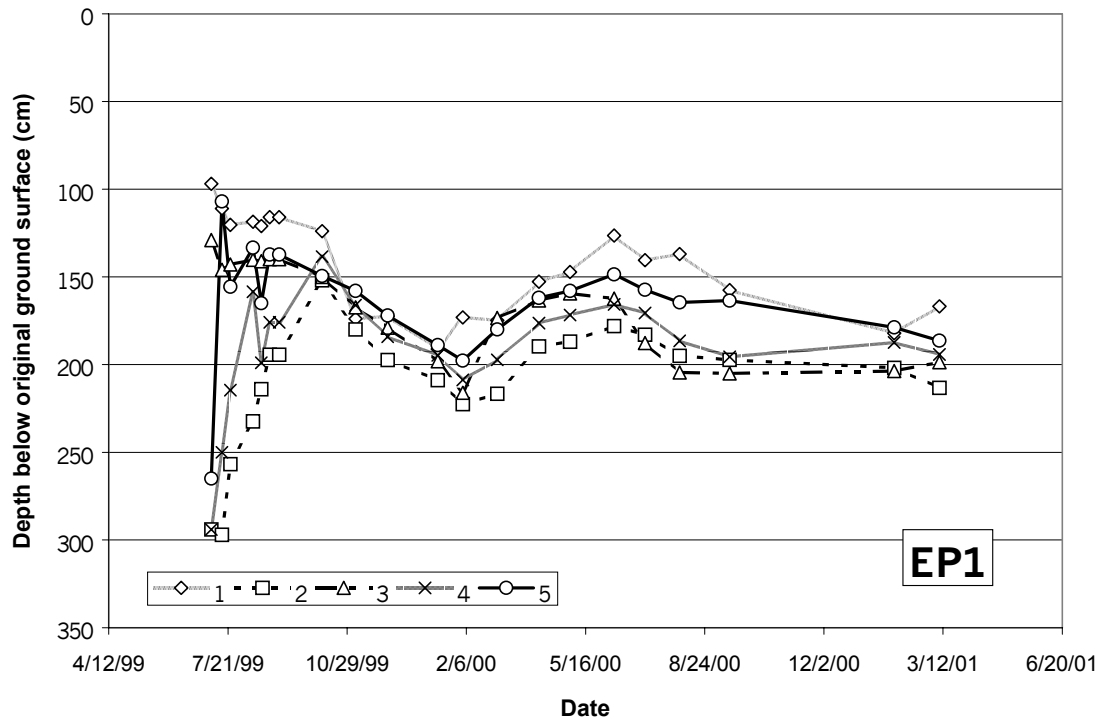
Figure 13: Depth to groundwater at EP-1.

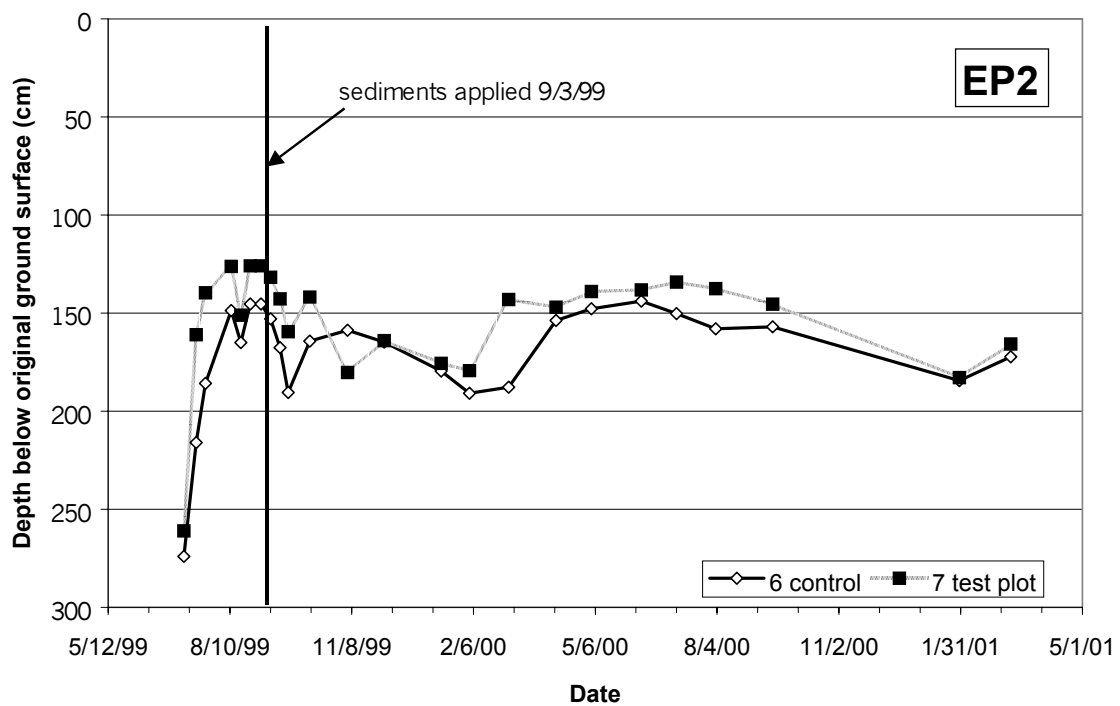
Figure 14: Depth to groundwater at EP-2.

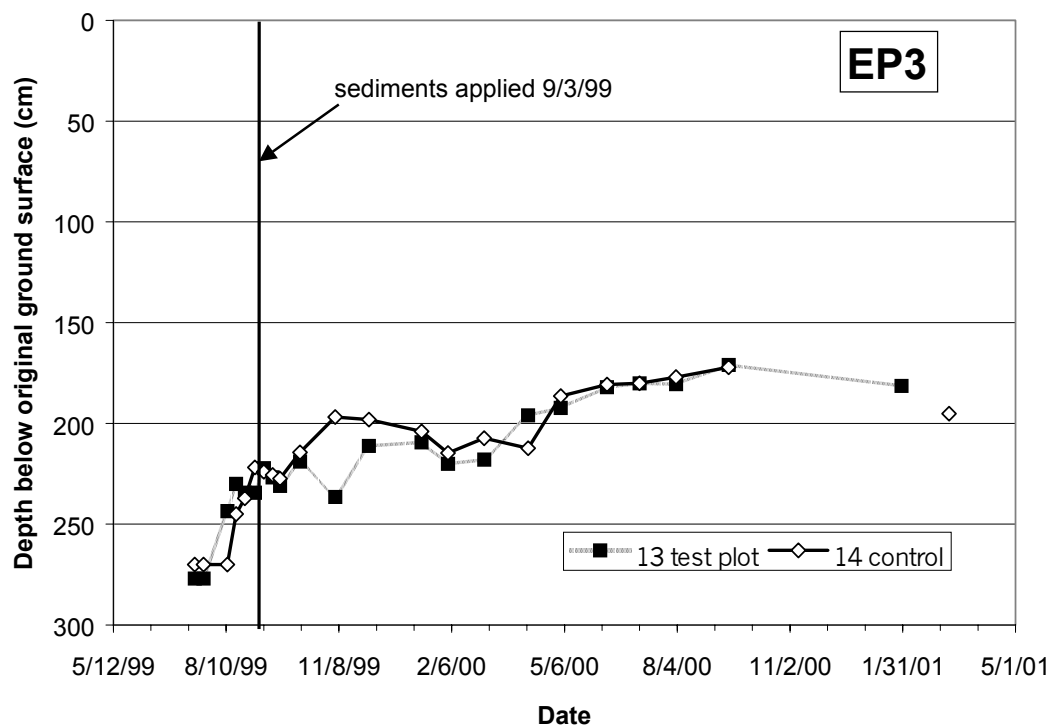
Figure 15: Depth to groundwater at EP-3.

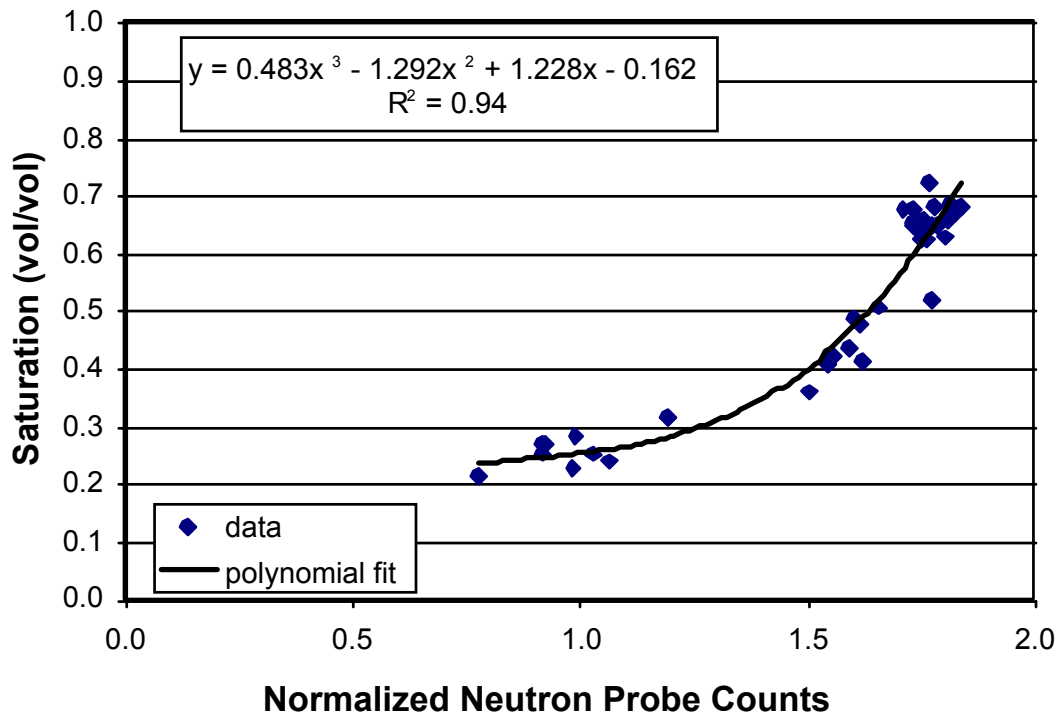
Figure 16: Calibration curve and equation for neutron probe counts in EP soil.

Effects of SLD sediment application on EP-2 and EP-3 are shown in Figures 18 and 19, respectively. Because the calibration curve shown in Figure 16 was derived from embankment sediments and not SLD sediments, the saturation data for SLD sediments (aboveground values) is qualitative. Nevertheless, the original high moisture content of the applied sediments is clearly shown on September 3, 2000 (thick line), the day of the application. The data shown here, and other data collected subsequently, indicate that the wet SLD sediment did not affect the hydrology of the underlying embankment sediments. This can be explained by high moisture-retentive properties of the SLD sediments and the very high evaporation rate observed in the field immediately after application.

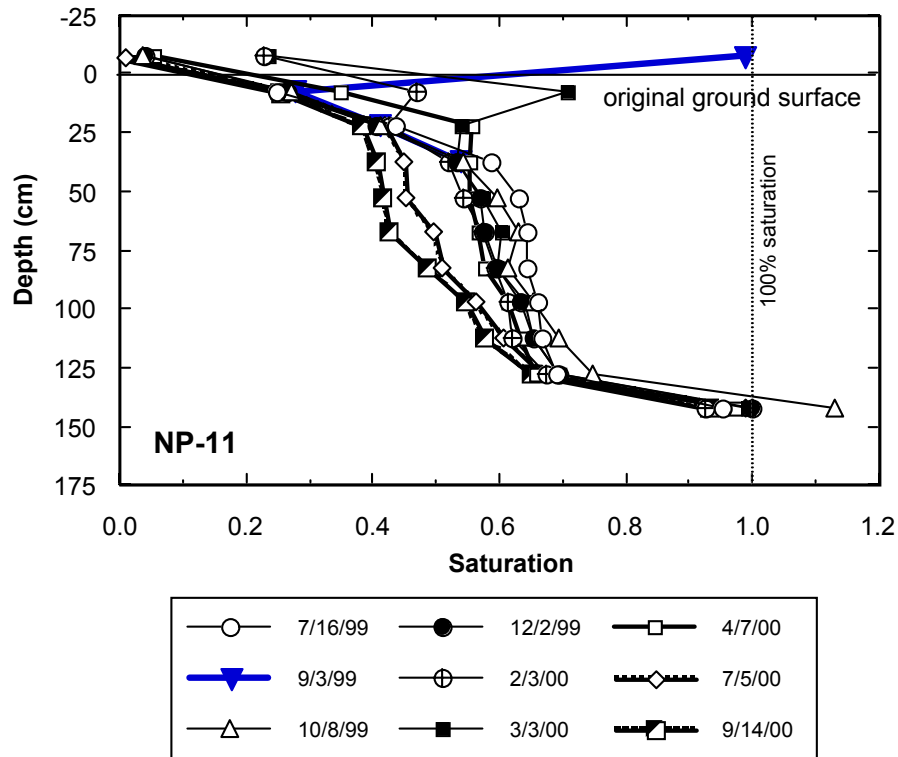
Figure 19: Sediment profile saturation at EP-3 (access hole NP-11) based on neutron probe measurements.

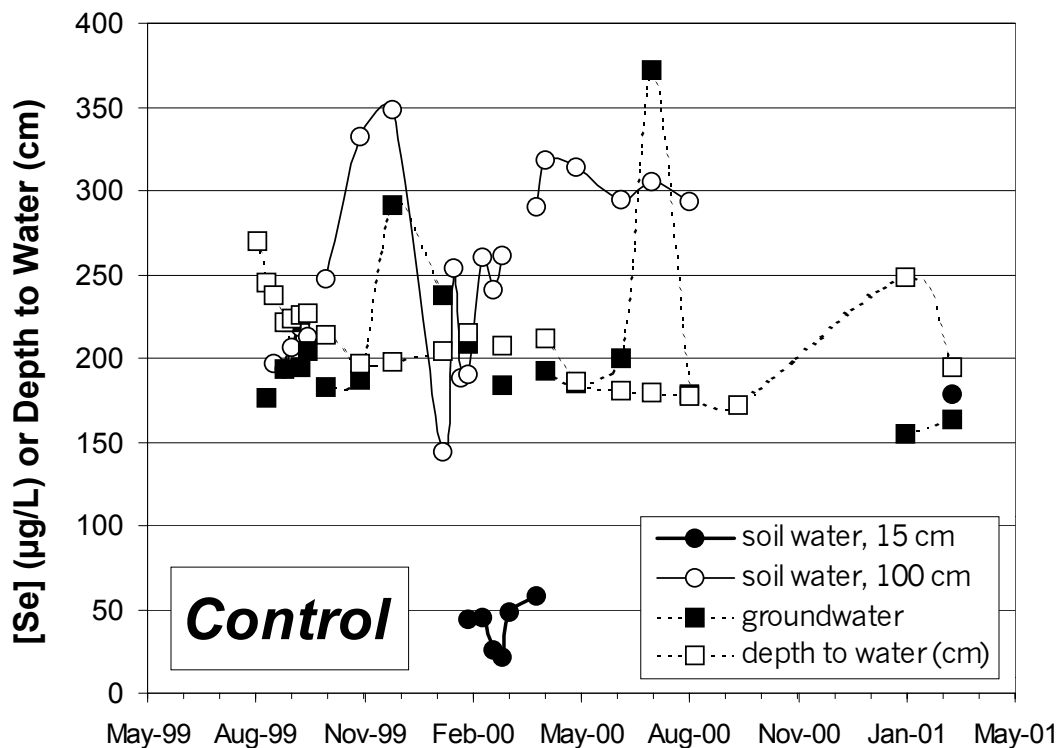
Figure 23: Soil water and groundwater Se and depth to water in the embankment control plot.

Soil water sampling in the embankment plots yielded nearly continuous data from the 100-cm-deep samplers, intermittent data from the 15-cm-deep samplers, and very rare data from the intermediate-depth samplers at 50 cm. This is due to limited rainfall infiltration, resulting in a matric potential close to or beyond the effective working range of vacuum lysimeters. The 100-cm samplers were close enough to the water table that they readily yielded samples. The 15-cm lysimeters produced samples following some of the larger rainfall events, specifically in February and March 2000. Samples from the 50-cm lysimeters were available on only a few days and in only 3 out of 14 monitoring clusters. Groundwater was collected regularly and without any difficulty. Selenium data from representative instrument clusters in EP-1, EP-2, and EP-3 are presented in Figures 20 through 22. Also shown is the depth to the water table at each of these locations. Corresponding results from a control site are shown in Figure 23.

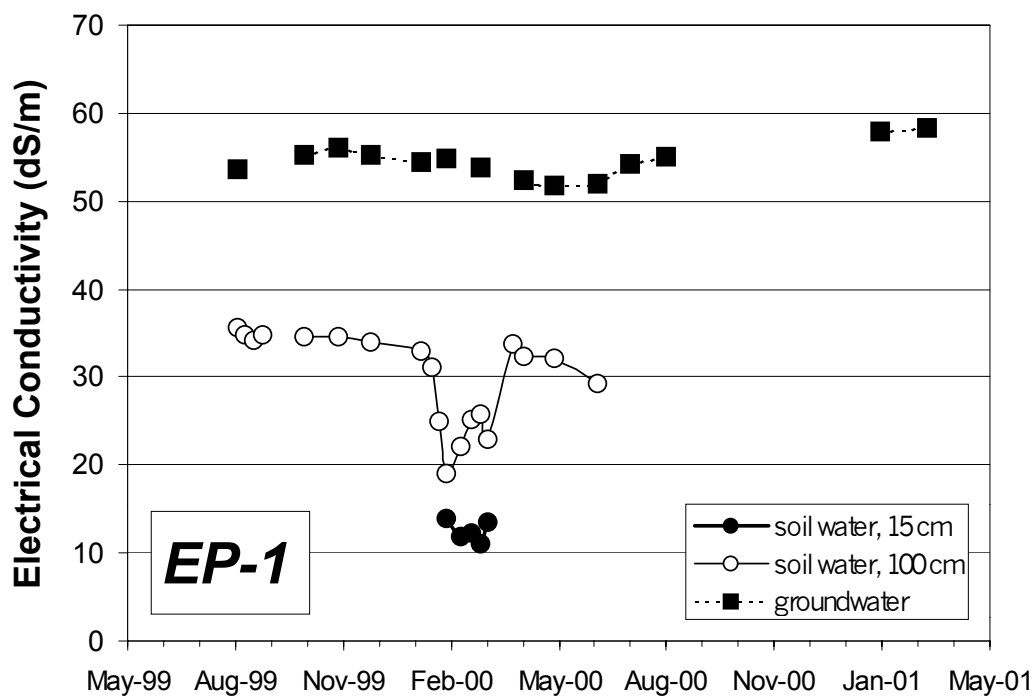
Figure 24: Soil water and groundwater electrical conductivity in EP-1.

Dissolved salts are represented by measurements of EC. Data for EP-1, EP-2, and EP-3 and a control site are shown in Figures 24 through 27, respectively. Unlike Se, EC is consistently and substantially higher in groundwater than in overlying soil water, and ranges from 50 to 55 decisiemens per meter. EC trends in soil water at 100 cm are very similar to Se trends, although observed changes have a smaller amplitude. The initial EC gradient with depth was representative of an unvegetated site. Because the site became vegetated during the spring and summer 2000, a change in the distribution of salts and Se was anticipated, though most of those changes will occur in the top 50 cm of soil, where solute monitoring is impeded by low soil moisture content. Nonetheless, EC measurements in 2001 showed increases in dissolved solids in both groundwater (Figures 24 through 27) and soil water (Figures 26 and 27), including the control plot.

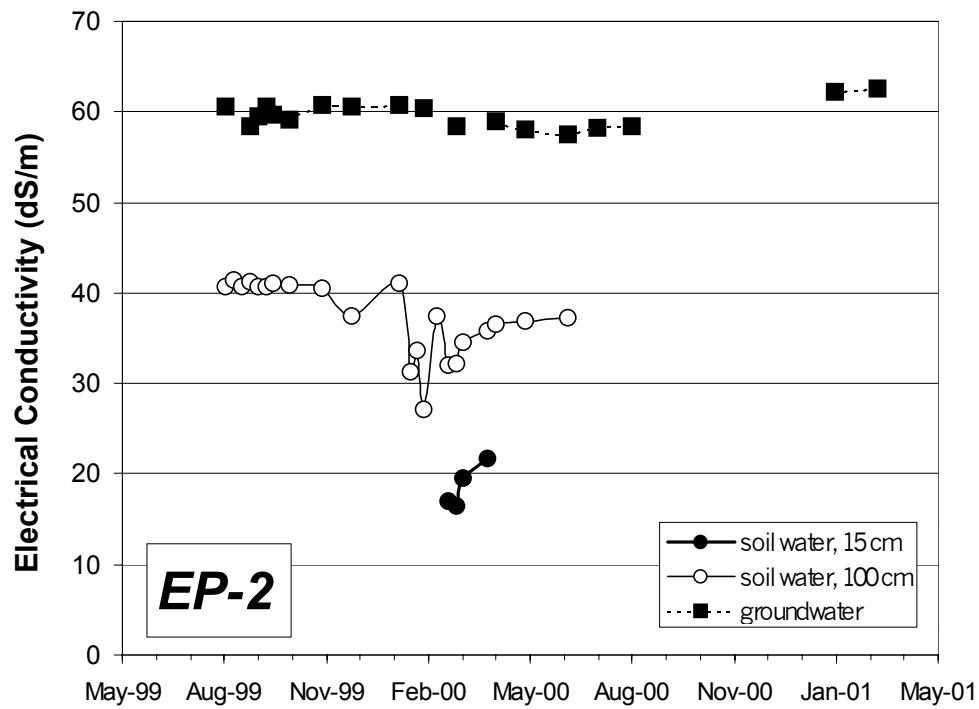
Figure 25: Soil water and groundwater electrical conductivity in EP-2.

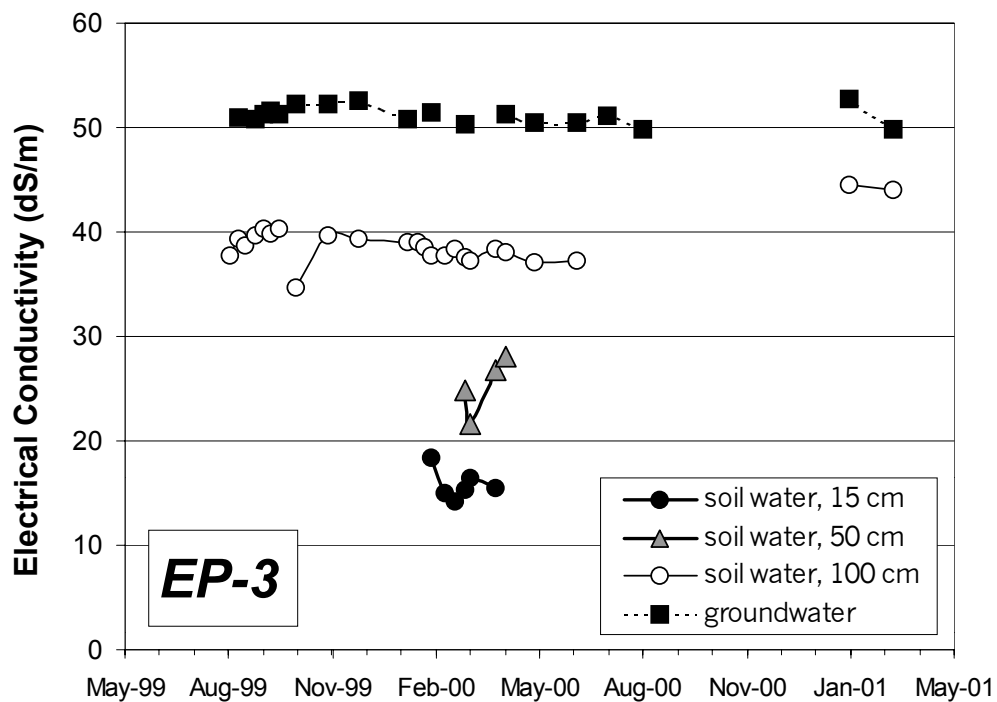
Figure 26: Soil water and groundwater electrical conductivity in EP-3.

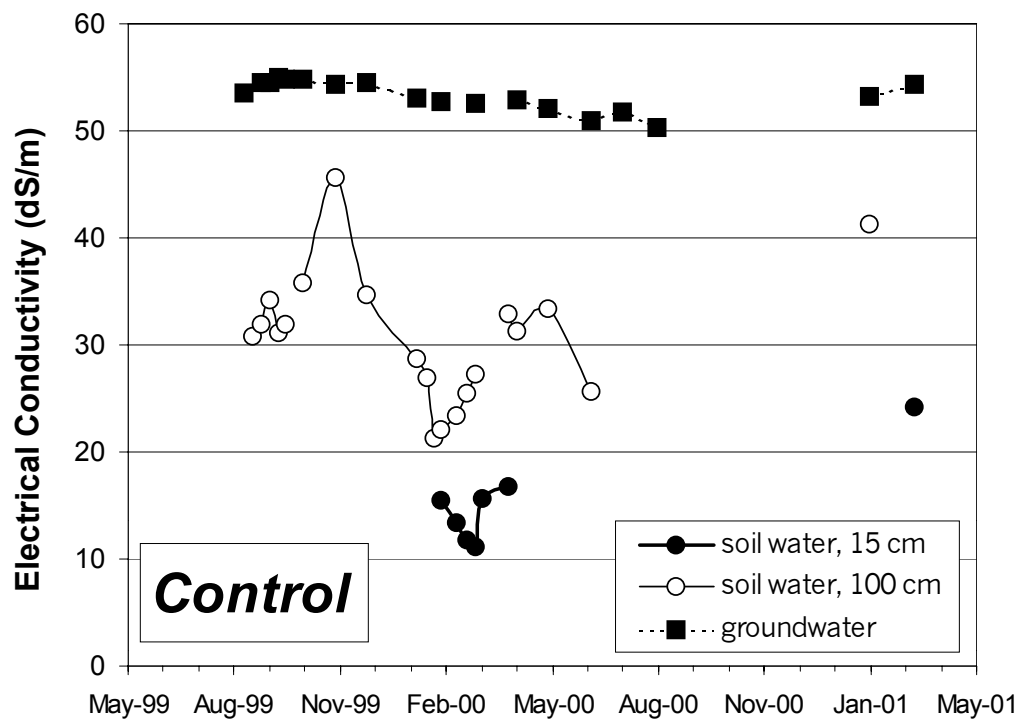
Figure 27: Soil water and groundwater electrical conductivity in the embankment control plot.

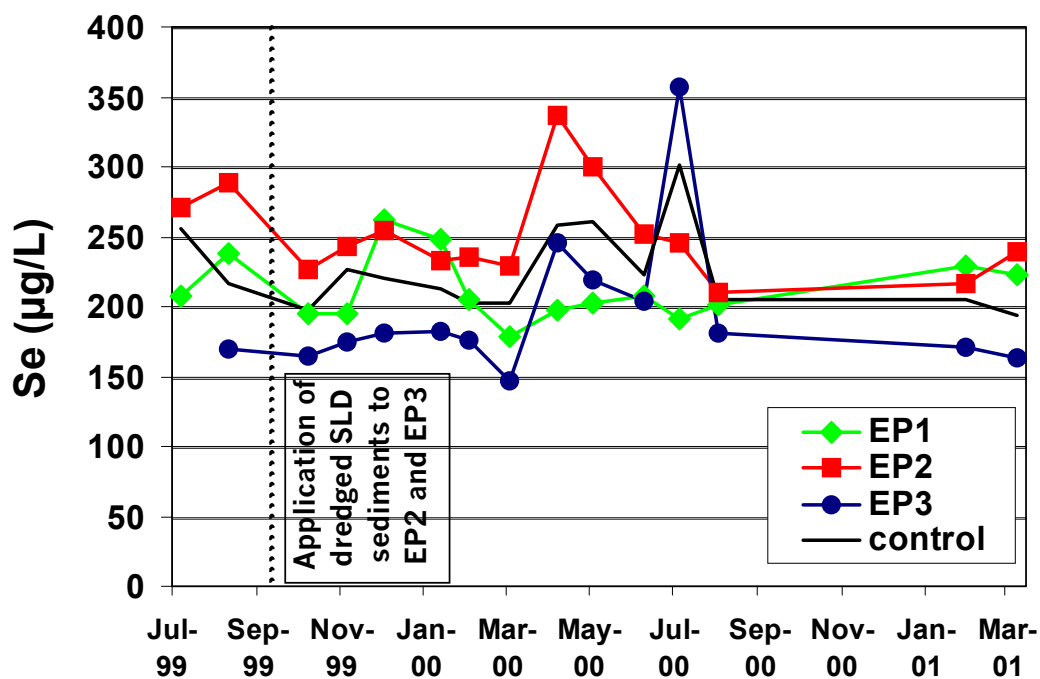
Figure 28: Groundwater Se in embankment test plot wells and in control wells.

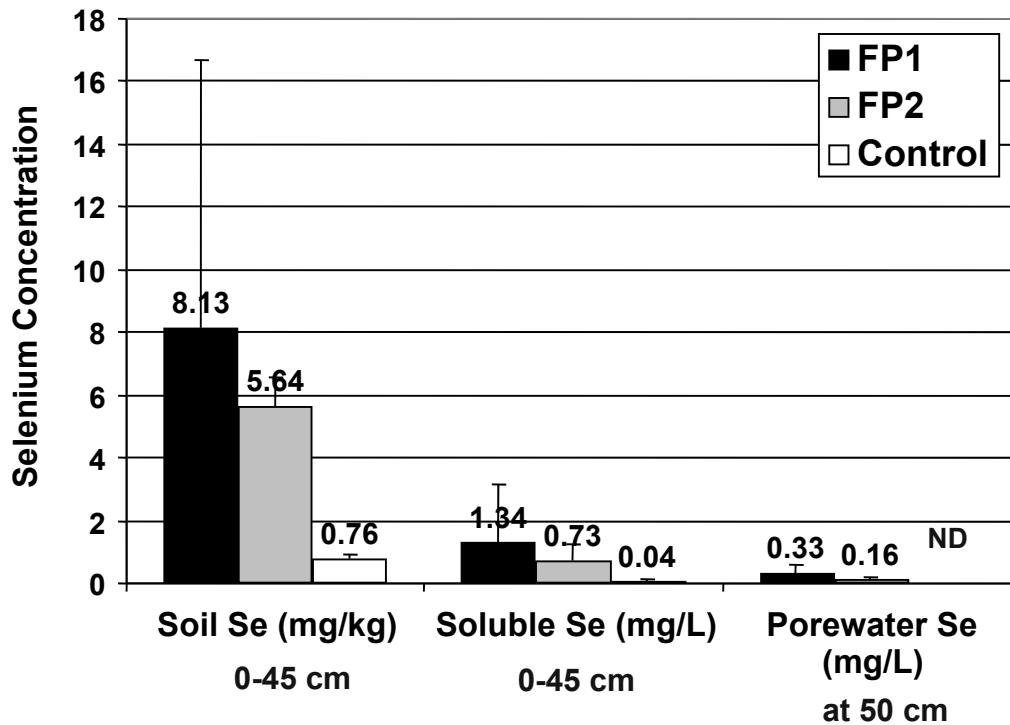
Figure 31: Total, water-soluble, and soil water Se in the Top 45 cm of FP-1, FP-2, and FP-C (control). Error bars represent one standard deviation on either side of the mean.

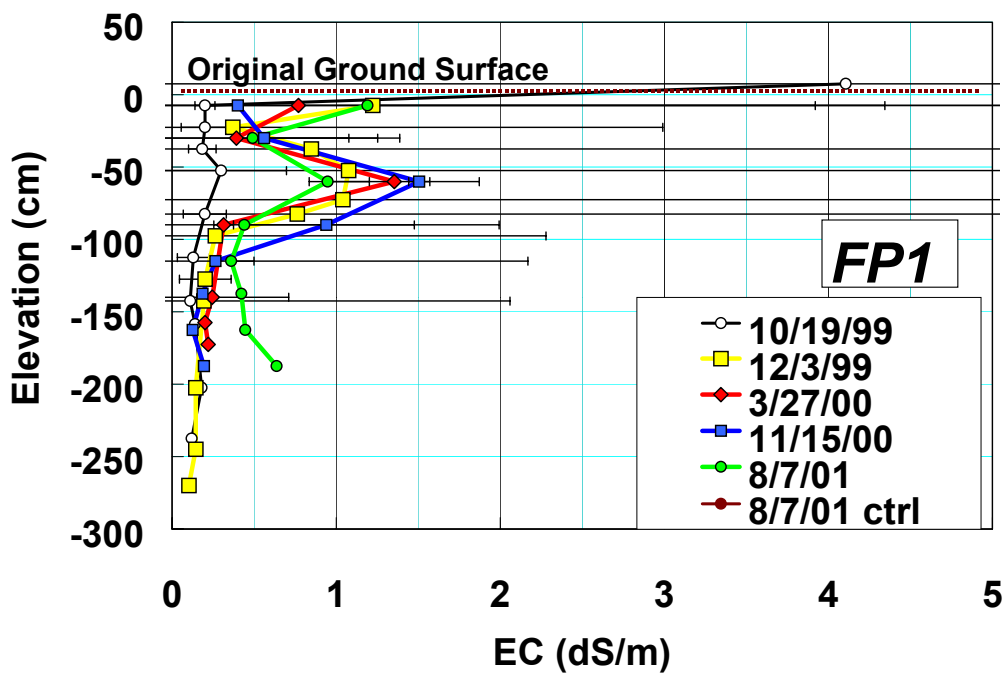
Figure 32: Electrical conductivity in water extracts of soils collected in FP-1. Error bars represent one standard deviation on either side of the mean.

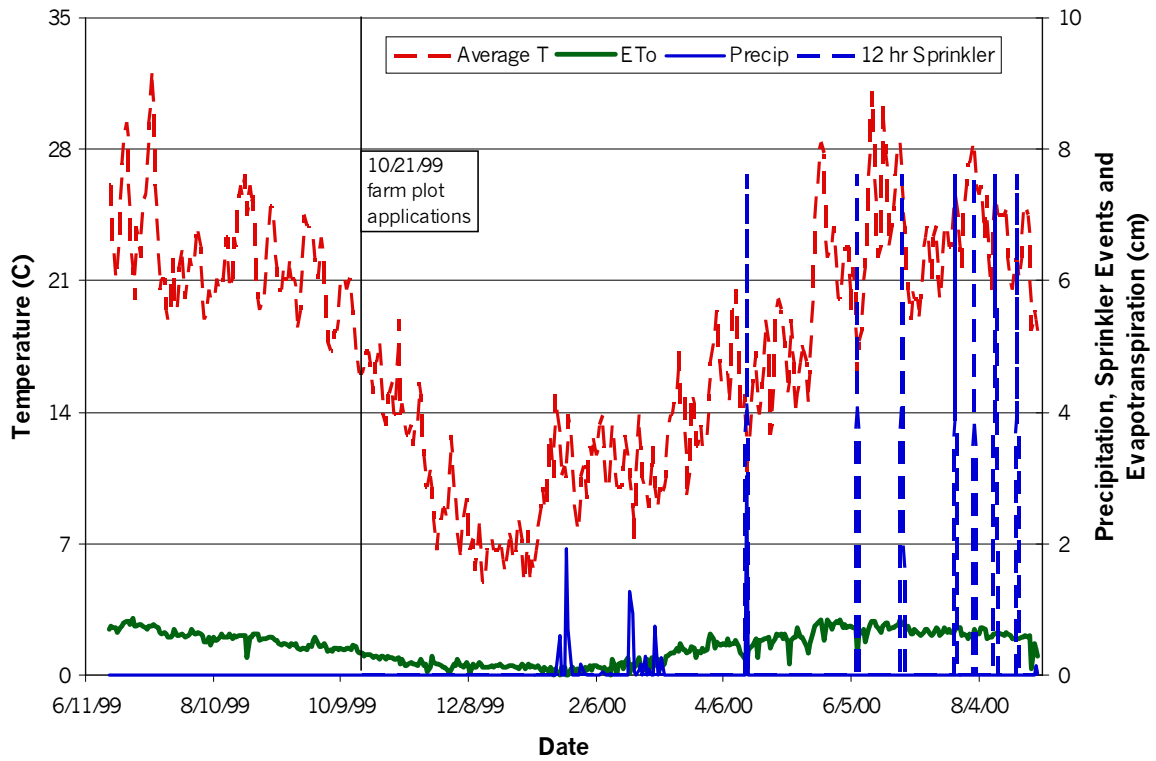
Figure 33: Daily weather records and irrigation events for farm plots.
